No. 1488373.0

SAMPLE DESCRIPTION:
Flooring Planks – KRONO 12mm laminate flooring
assembly with D3 PVA adhesive applied in the joints.

ISO 4760:2022(E) - LAMINATE FLOORING – TOPICAL MOISTURE RESISTANCE – ASSEMBLED JOINT (MODIFIED)

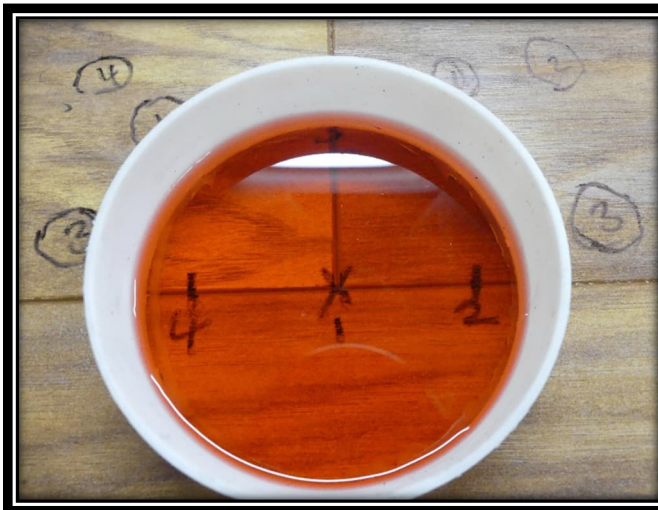
After 24 hrs With Water

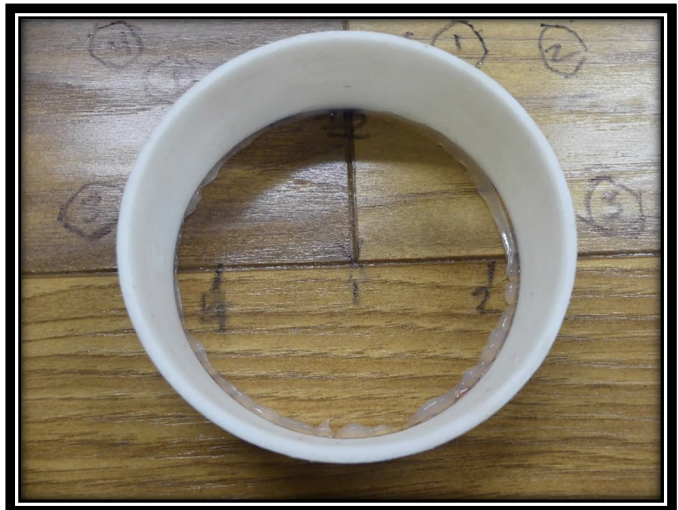
Wet Swell

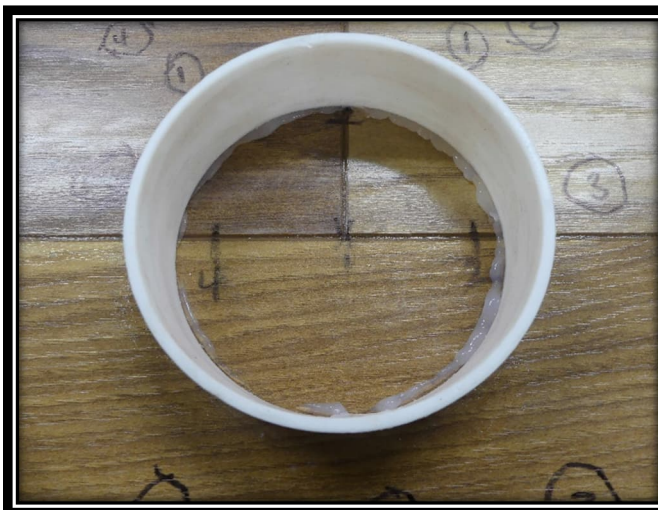
Recovered Swell

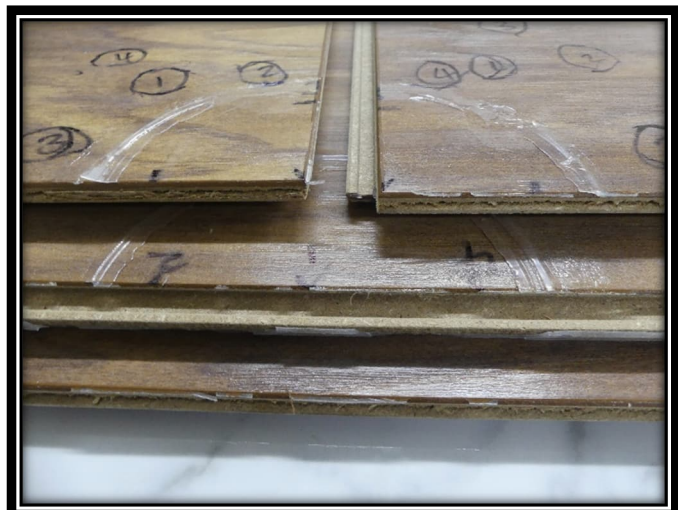
Recovered Swell (Disassembled)
