No. 1488374.8

SAMPLE DESCRIPTION:
Flooring Planks – NZCORE 8mm SPC flooring
assembly with D3 PVA adhesive applied in the joints.

ISO 4760:2022(E) - LAMINATE FLOORING – TOPICAL MOISTURE RESISTANCE – ASSEMBLED JOINT (MODIFIED)

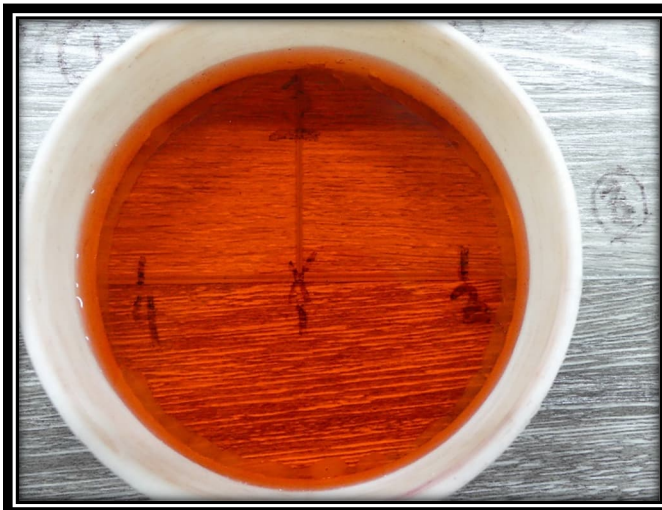
After 24 hrs With Water

100 mls of dye solution was applied onto the sample surface. It was poured into a cylinder 100mm diameter placed in the centre of the sample at the "T joint." Sealant was used at the plank/cylinder interface to avoid leakage.

The sample was left at 20°C, 65% Relative Humidity room conditions for 24 hours after the dye was added and then examined for dye penetration through the backing (not 23°C, 50% RH as stated in the method).

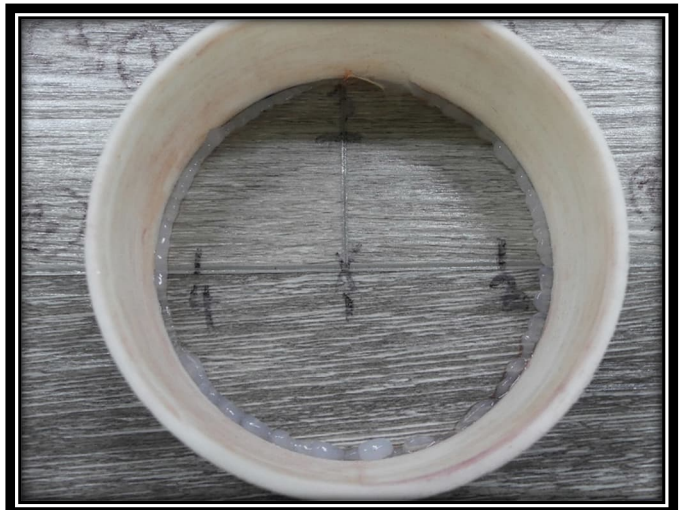
Wet Swell

Quantitative Results:	Wet Swell (mm)			Recovered Swell (mm)		
	Specimen 1	Specimen 2	Specimen 3	Specimen 1	Specimen 2	Specimen 3
Final Average Results (Positions 2 to 4)	0.06	0.01	0.01	0.05	0.01	0.01
Final Results (Position 1)	0.05	0.04	0.02	0.01	0.00	0.00

Wet Swell			Recovered Swell		
	Specimen 1	Specimen 2	Specimen 3	Specimen 1	Specimen 2	Specimen 3
Qualitative Ratings (individual results):	1	1	1	1	1	1

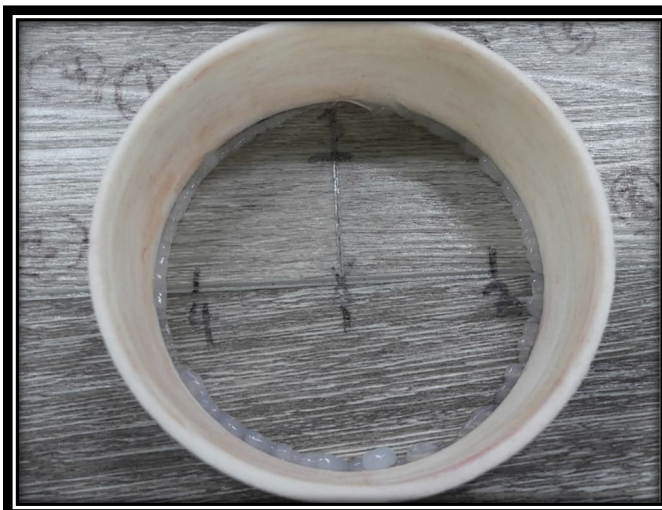
Recovered Swell

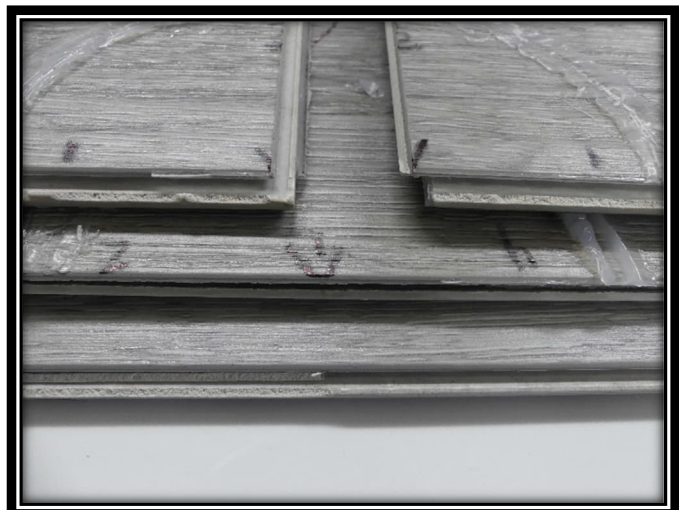
Recovered Swell (Disassembled)

Disassembly Observations:	Specimen 1	Specimen 2	Specimen 3
Migration of water along the upper surface:	No	No	No
Migration of water to the underside:	No	No	No
