No. 1441925.3

SAMPLE DESCRIPTION:
Flooring Planks – Atwood SPC

ISO 4760:2022(E) - LAMINATE FLOORING – TOPICAL MOISTURE RESISTANCE – ASSEMBLED JOINT (MODIFIED)

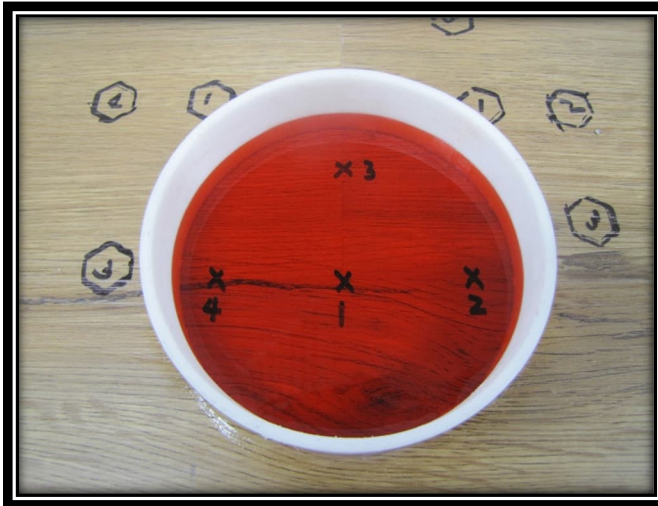
24 hrs With Water

Weights were placed on the outer corners of the test specimens to keep the samples flat throughout the test procedure. 100 mls of dye solution was applied onto the sample surface. It was poured into a cylinder 100mm diameter placed in the centre of the sample at the "T joint." Sealant was used at the plank/cylinder interface to avoid leakage.

Observations:	Specimen 1	Specimen 2	Specimen 3
Migration of water along the upper surface:	No	No	No
Migration of water to the underside:	No	No	No
