No. 1488375.5

SAMPLE DESCRIPTION:
Flooring Planks – WaterPRO SPC flooring assembly
with D3 PVA adhesive applied in the joints.

ISO 4760:2022(E) - LAMINATE FLOORING – TOPICAL MOISTURE RESISTANCE – ASSEMBLED JOINT (MODIFIED)

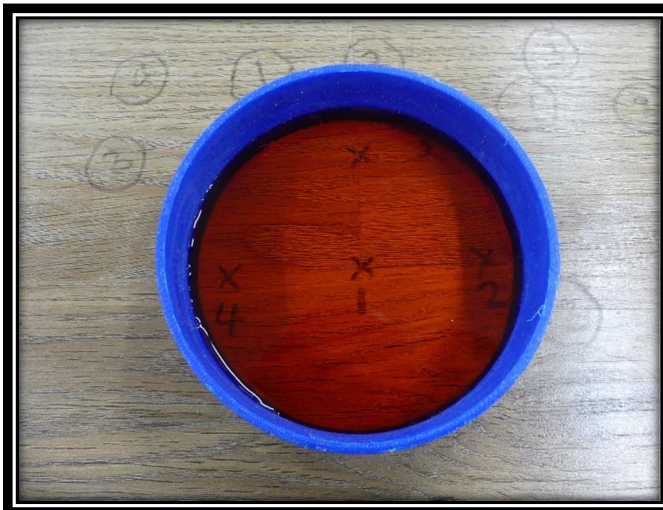
After 24 hrs With Water

100 mls of dye solution was applied onto the sample surface. It was poured into a cylinder 100mm diameter placed in the centre of the sample at the "T joint." Sealant was used at the plank/cylinder interface to avoid leakage.

The sample was left at 20°C, 65% Relative Humidity room conditions for 24 hours after the dye was added and then examined for dye penetration through the backing (not 23°C, 50% RH as stated in the method).

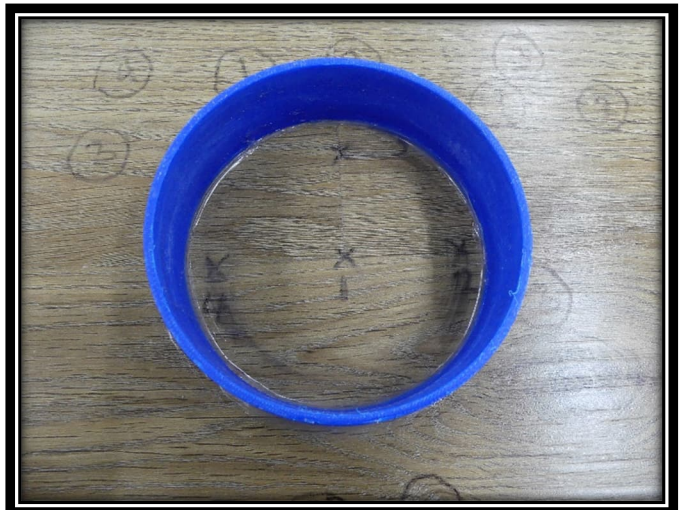
Wet Swell

- 1 = No change - Little to no noticeable change in edge swell or panel surface lift
- 2 = Slight swelling - Slight swelling, small ridge along one or more joints, very little if any panel surface lift
- 3 = Moderate - Noticeable edge swelling and some panel surface lift extending away from joint
- 4 = Objectional - Severely raise edge and swelling extending noticeably under the panel surface
- 5 = Failed test - Water leaked out of the ring, leaving no continuous film of water inside the ring
(this grade is given even if there is no swell of the edge joint)

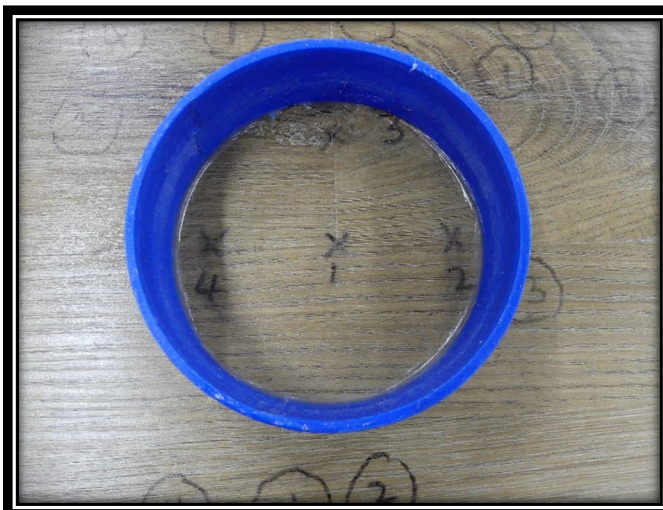
Recovered Swell

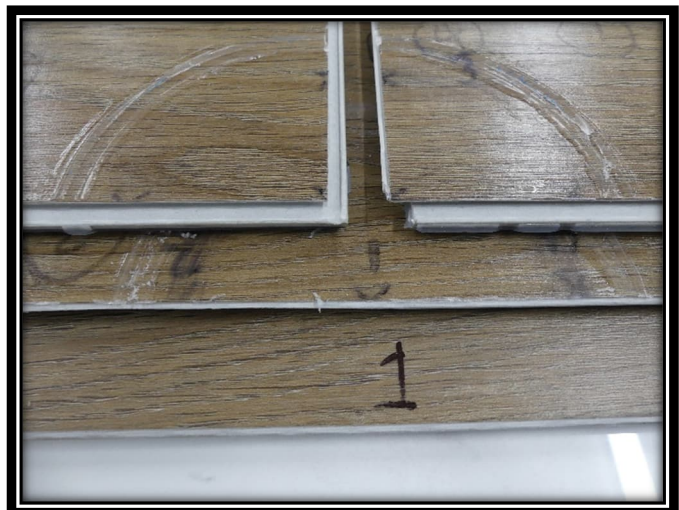
Recovered Swell (Disassembled)
