No. 1482068.2R

SAMPLE DESCRIPTION:
Flooring planks – Floorco wood flooring assembly with
D3 PVA adhesive applied in the joints.

ISO 4760:2022(E) - LAMINATE FLOORING – TOPICAL MOISTURE RESISTANCE – ASSEMBLED JOINT (MODIFIED)

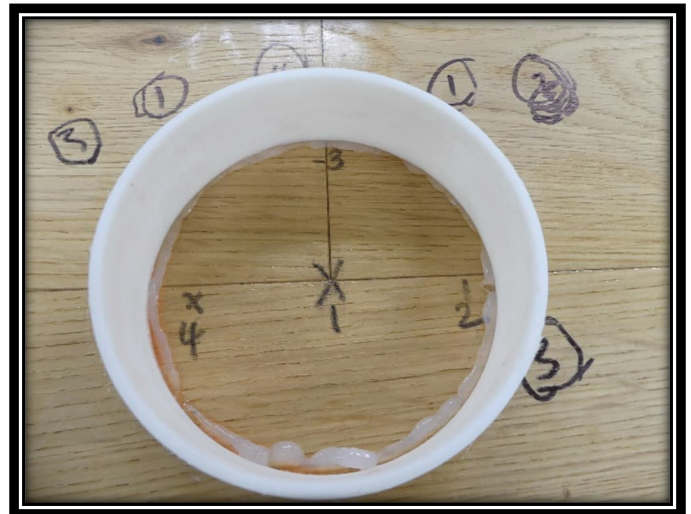
Wet Swell

- 1 = No change - Little to no noticeable change in edge swell or panel surface lift
- 2 = Slight swelling - Slight swelling, small ridge along one or more joints, very little if any panel surface lift
- 3 = Moderate - Noticeable edge swelling and some panel surface lift extending away from joint
- 4 = Objectional - Severely raise edge and swelling extending noticeably under the panel surface
- 5 = Failed test - Water leaked out of the ring, leaving no continuous film of water inside the ring
(this grade is given even if there is no swell of the edge joint)

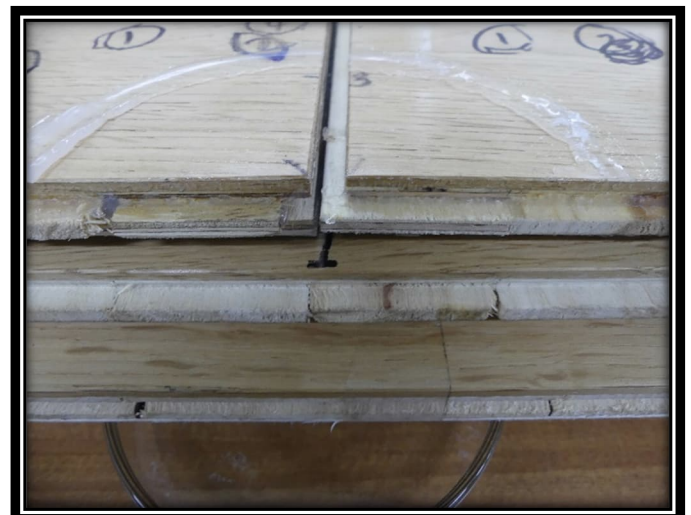
Recovered Swell (Disassembled)
