No. 1481936.1R

SAMPLE DESCRIPTION:
Flooring planks – Homy wood flooring assembly with D3
PVA adhesive applied in the joins.

ISO 4760:2022(E) - LAMINATE FLOORING – TOPICAL MOISTURE RESISTANCE – ASSEMBLED JOINT (MODIFIED)

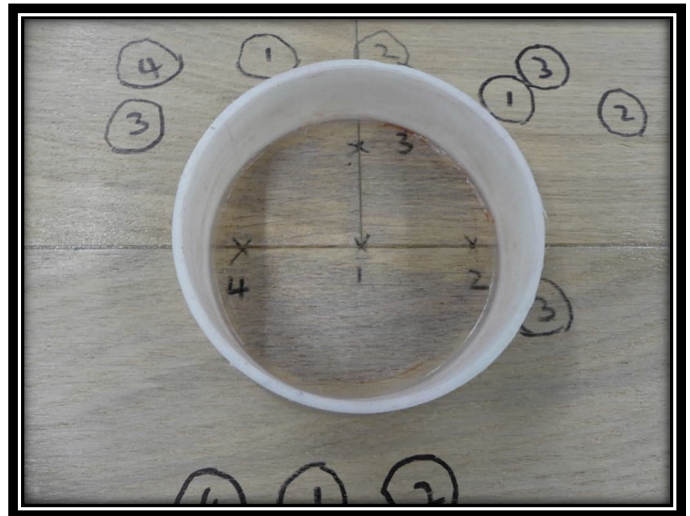
Wet Swell

- 1 = No change - Little to no noticeable change in edge swell or panel surface lift
- 2 = Slight swelling - Slight swelling, small ridge along one or more joints, very little if any panel surface lift
- 3 = Moderate - Noticeable edge swelling and some panel surface lift extending away from joint
- 4 = Objectional - Severely raise edge and swelling extending noticeably under the panel surface
- 5 = Failed test - Water leaked out of the ring, leaving no continuous film of water inside the ring
(this grade is given even if there is no swell of the edge joint)

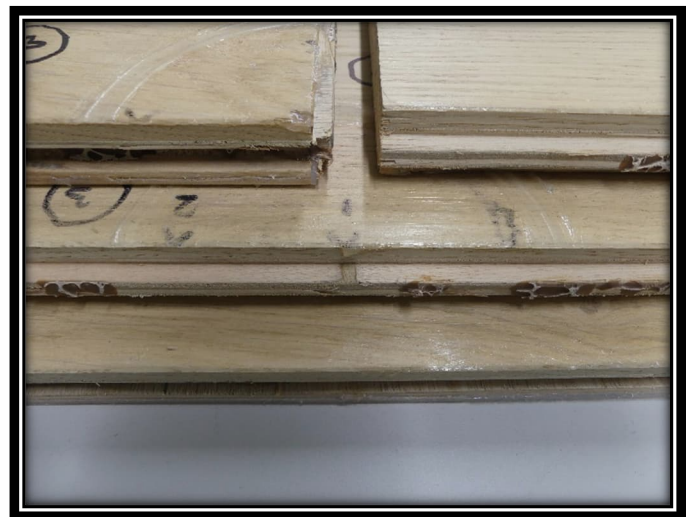
Recovered Swell (Disassembled)
