# No. 1487243.6

SAMPLE DESCRIPTION:  
Flooring Planks – VSPC Woodface 8mm flooring  
assembly with D3 PVA adhesive applied in the joints.

## ISO 4760:2022(E) - LAMINATE FLOORING – TOPICAL MOISTURE RESISTANCE – ASSEMBLED JOINT (MODIFIED)

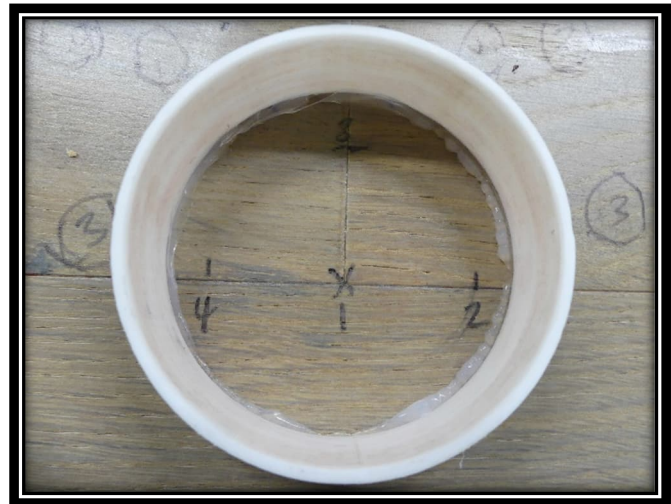
Wet Swell

- 1 = No change - Little to no noticeable change in edge swell or panel surface lift
- 2 = Slight swelling - Slight swelling, small ridge along one or more joints, very little if any panel surface lift
- 3 = Moderate - Noticeable edge swelling and some panel surface lift extending away from joint
- 4 = Objectional - Severely raise edge and swelling extending noticeably under the panel surface
- 5 = Failed test - Water leaked out of the ring, leaving no continuous film of water inside the ring  
(this grade is given even if there is no swell of the edge joint)
