# TEST REPORT

ANTICO & DUKE Engineered wood flooring

230822002SHF-001

Intertek Testing Services Shenzhen Ltd. Shanghai Fengxian Branch

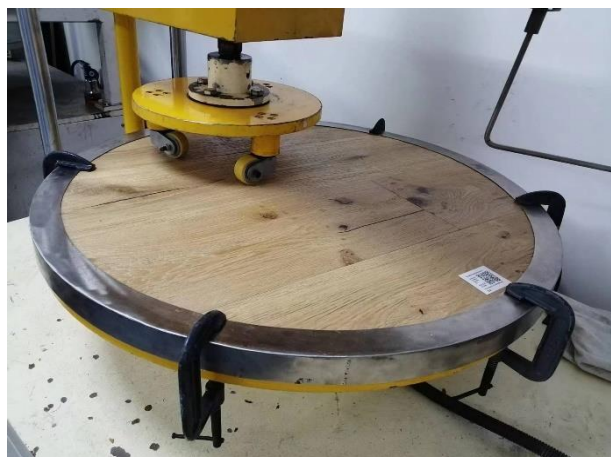
### Test Photo:

Type of damage	Observation (Yes/No)	Verdict
Delamination	No	Pass
Opening of joints	No	
Surface damage	No	
Crazing	No	
Maximum opening	0.06mm	No requirement Report the result
Maximum height differences	0.29mm

After test

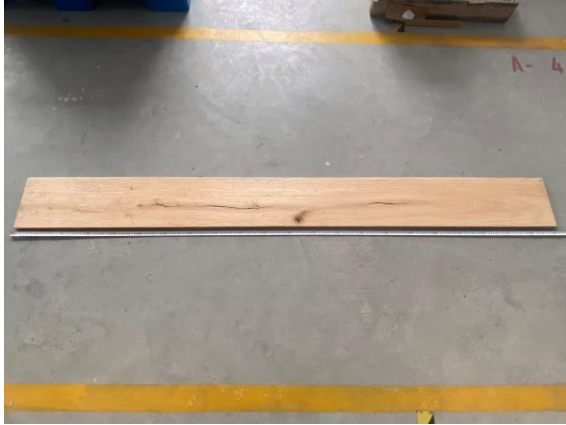
Front view(Test surface)

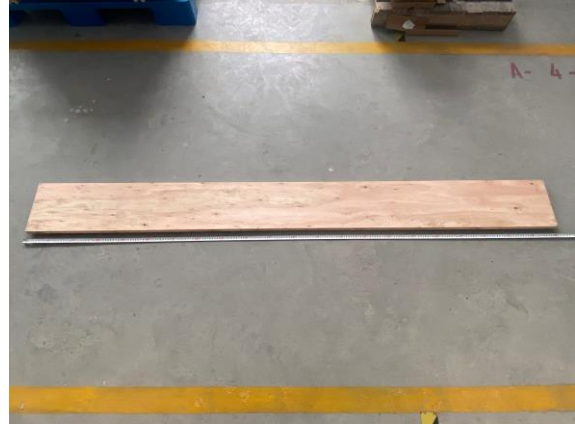
Back view
