TEST REPORT

No.: GZIN2312001211CM01_EN

Sample Name Floorco Rustic Tiles

Test Item: Wet Pendulum Test Sample Description: See photo.

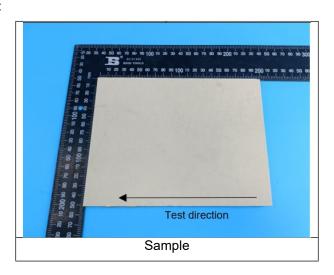
Original Sample Photo:

Product Specification 200*150mm

Specimen: 200mm×150mm×9.0mm, 5pcs

Type of slider: Slider 55 Sliding length: 126mm Test direction: see photo
